Pushover and nonlinear time history analysis evaluation of a RC building collapsed during the Van (Turkey) earthquake on October 23, 2011

Abstract The nonlinear seismic behavior of a collapsed reinforced concrete (RC) residential building in the city of Van in Turkey is investigated by the static pushover and nonlinear time history analyses. The selected RC structure was designed according to the 1975 version of Turkish Earthquake Code (TEC-1975). The building had experienced heavy damage, and it was demolished in the Van earthquake on October 23, 2011. The 2007 version of Turkish Earthquake Code (TEC-2007) is considered for the assessing seismic performance evaluation of the selected RC building. The RC structure presents collapse performance level under the earthquake loads. Besides, the analytical solutions show that different performance levels for the sections are obtained from the pushover and nonlinear time history methods.

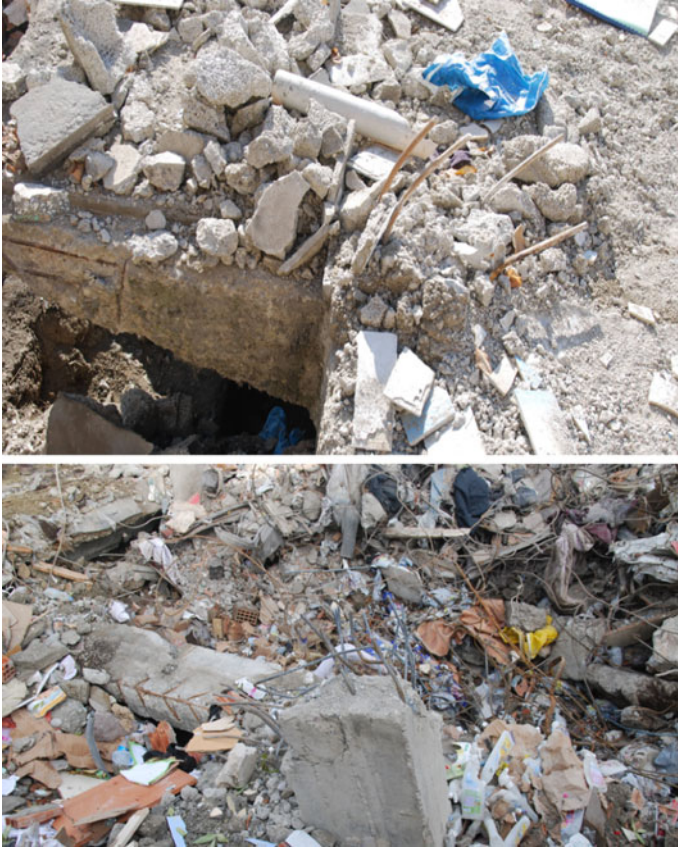
It can be seen from Fig. 2 that the building collapsed completely in October 23, 2011 Van earthquake. One of the important deficiencies in the existing building stock is the insufficient amount of transverse reinforcement as shown in Fig. 3. In addition, poor workmanship and concrete, and insufficient steel detailing were observed during the investigation of the debris of the building.

Fig. 2 Views of the collapsed building after Van earthquake

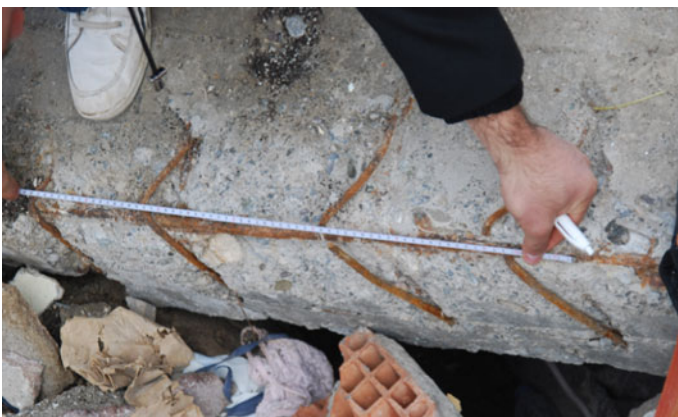
Fig. 3 View of transverse reinforcement of the building

It should also be noted that considerably small displacement drift capacities for IO and LS performance levels in residential building are associated with the existence of weak column–strong beam mechanism and insufficient amount of transverse reinforcement. These columns fail in shear before global yielding. Because of this behavior, the building became incapable of satisfying IO and LS performance levels before yielding.

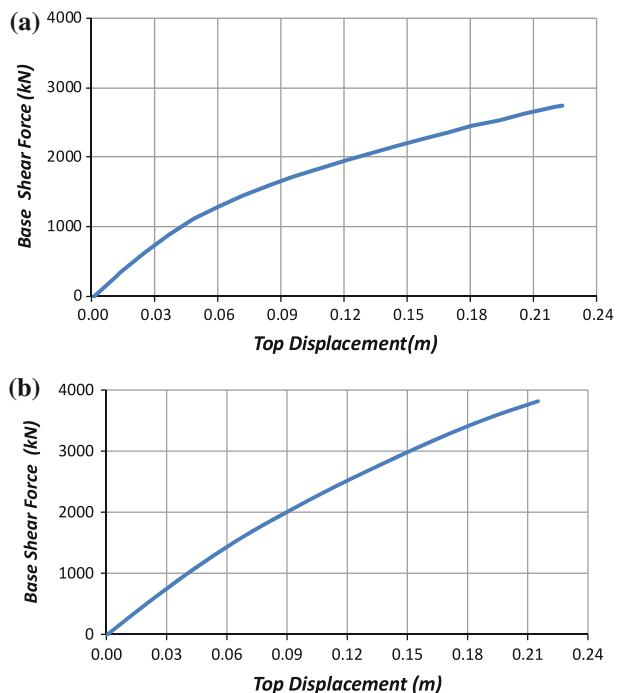
The capacity curves of the building for *X* and *Y* directions are obtained by static pushover analysis, and performance points are determined by TEC-2007 as seen in Fig. 10.

Fig. 10 Capacity curves for (a) *X* direction and (b) *Y* direction by pushover analysis for 6-story buildings

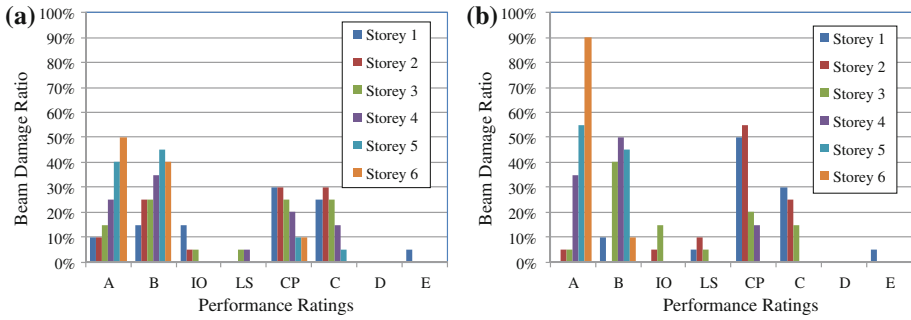
It can be seen from the result of the nonlinear time history analysis through the X direction (Fig. 16a) that there was no damage in 30 beams (25 %), minimum damage occurred in 37 beams (30.83 %), marked damage occurred in 7 beams (5.83 %), advanced damage occurred in 45 beams (37.5 %) and 1 beam (0.83 %) of the total 120 beams that

Fig. 16 Beams performance levels of (a) X direction (b) Y direction of residential RC building obtained by nonlinear time history analysis

collapsed. It is also shown in the result of the nonlinear time history analysis through the Y direction (Fig. 16b) that there was no damage in 37 beams (30.83 %), minimum damage occurred in 27 beams (22.5 %), marked damage occurred in 10 beams (8.33 %), advanced damage occurred in 45 beams (37.5 %) and 1 beam (0.83 %) of the total 120 beams that collapsed.

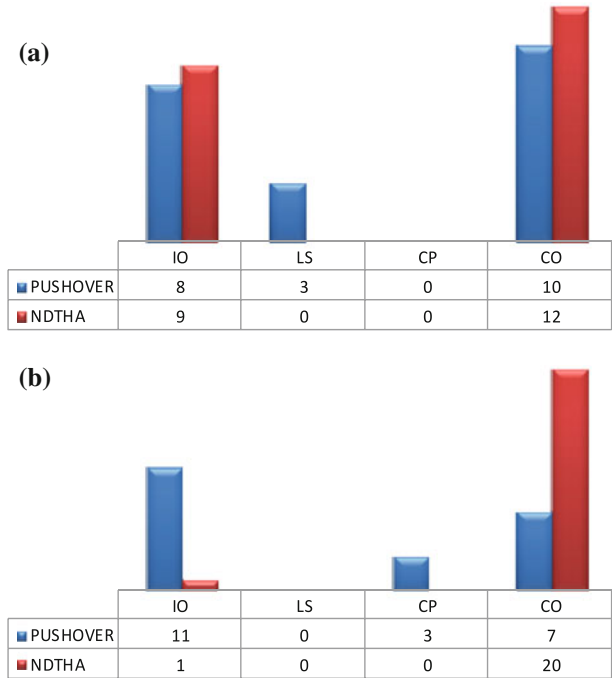
Fig. 18 Comparison chart of the methods (a) X direction and (b) Y direction for the first-story columns

The performances of the first-story elements under the earthquake are compared for pushover analysis and nonlinear dynamic time history analysis (NDTHA) in Figs. 17 and 18. The results from pushover analysis show lower damage ratios for the first-story beams and columns than those of the nonlinear time history analysis. The damage ratio indicates relatively high dispersion between the results from NDTHA. The average differences between the damage levels of these two methods are about 50 %.

In addition to these, the results from linear analysis and pushover analysis show lower damage ratios for the first-story beams and columns than those of the nonlinear dynamic analysis.
